LYNN COMMONS

LYNN, MA

MASTER PLAN

FREDERICK DOUGLASS BANDSTAND,
LYNN COMMON HISTORIC DISTRICT, LYNN,
MASSACHUSETTS 01901

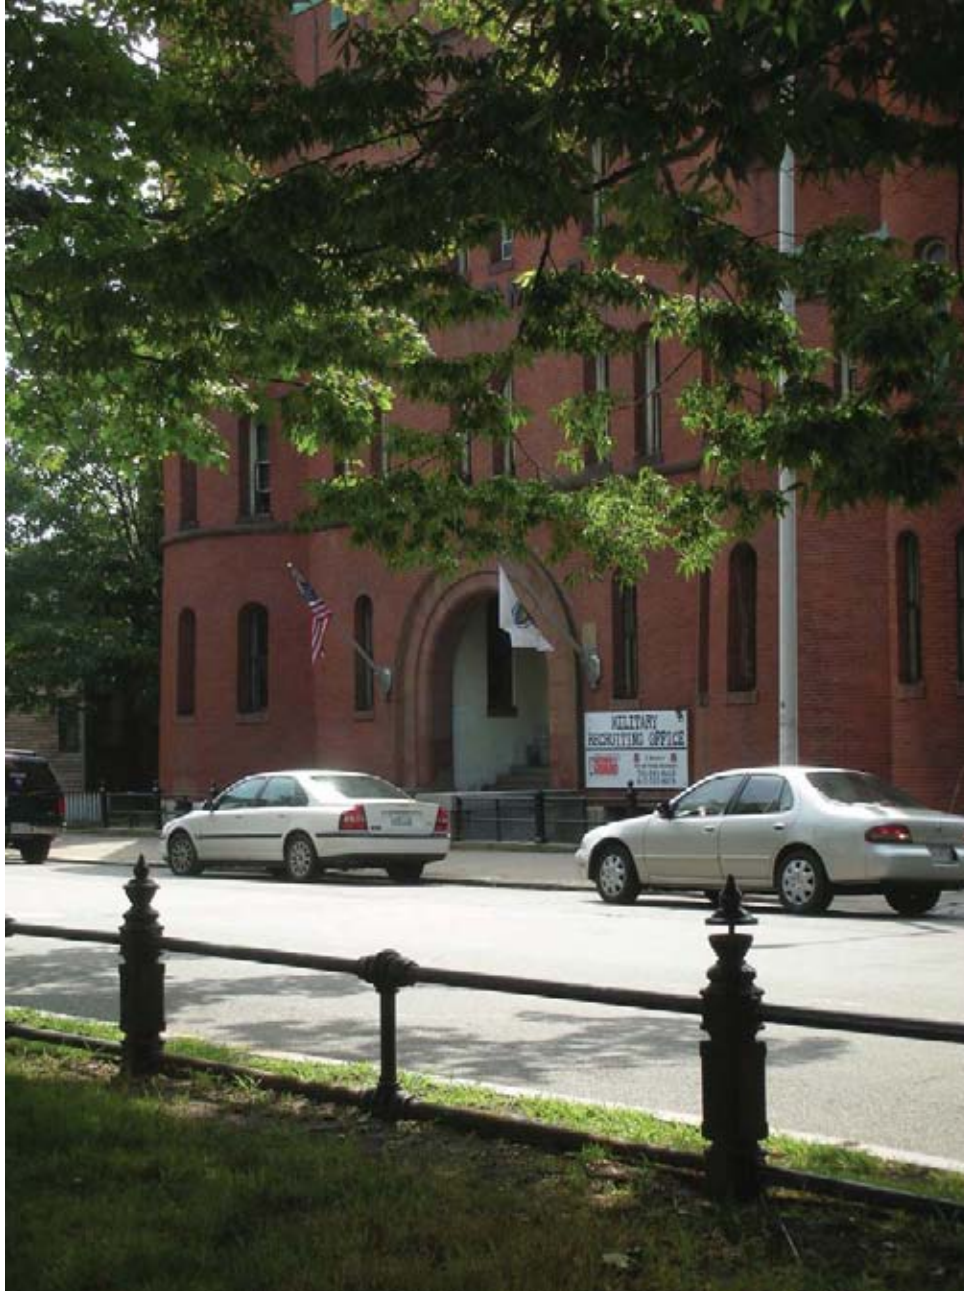
Fence at small Common - July 2010

A distinctive, black ornamental fence surrounds the small Common and needs repair. The City has the mold for the fence that surrounds the section of the Common between Franklin and Hanover Streets. The City would like to keep the fence around the small common, but would prefer to keep the big common open. In the past, cars hit the fence that used to surround the big common and damaged the fence. These accidents led to the removal of the fence.

- Repair of ornamental fence surrounding the Small Common,
- Addition of one panel of black ornamental ironwork fence to each of the two granite columns at the two entries to the Large Common,

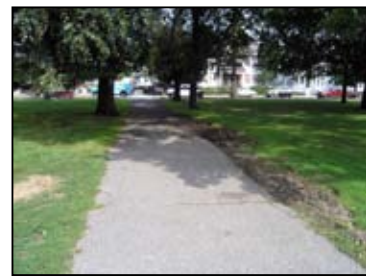
- DAMAGED GRASS AT EDGE OF PATH
- TREES SCREEN VIEW TO NEARBY RESIDENCES

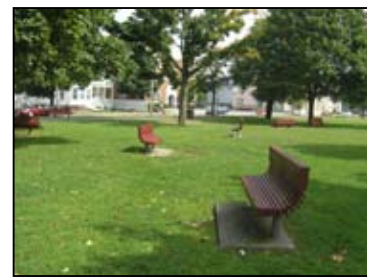
- GRASS HAS GROWN OVER STONE DUST PATH . BENCHES NOW APPEAR TO BE IN MIDDLE OF LAWN

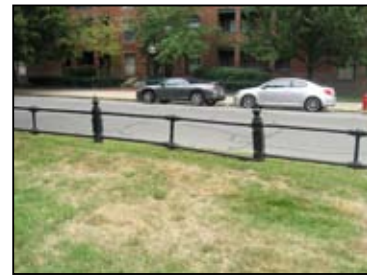
- JOHN MORRISSEY MEMORIAL
- LAWN NEEDS TO BE REFURBISHED

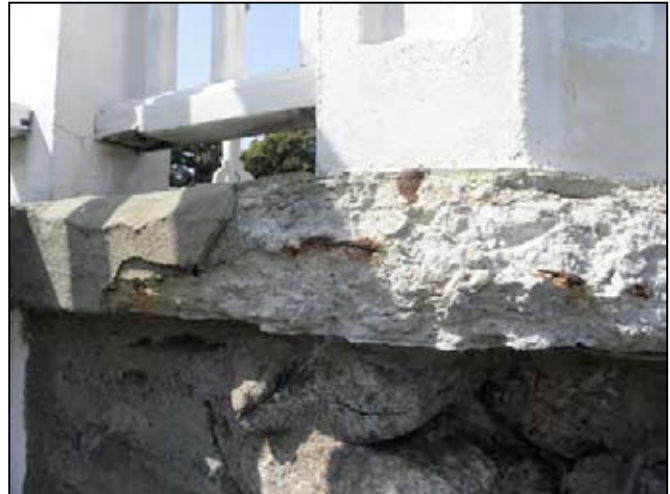
In 1987 a skim coat of masonry was applied to the entire floor and edges of the concrete. There is deterioration and loss of concrete at some of the northeastern corner edges where the floor supports the concrete column pedestals, also installed in 1987.

Detail of Deterioration of the Northeast Corner of Floor Slab

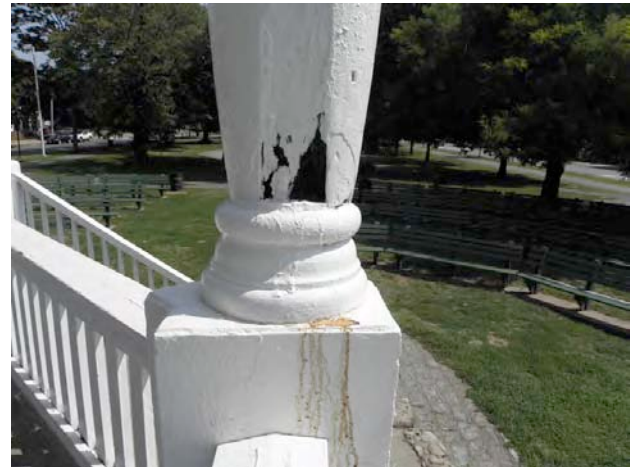
Wooden Columns & Concrete Pedestals: The deteriorated wooden columns represent the most serious threat to the integrity of the bandstand. There are eight original wooden columns spaced 8 feet apart in a perfect octagon. The four columns on the south side have serious rot and loss of structural integrity (three at the bottom and one at the top). A screwdriver easily penetrated 5" into column 1. We strongly recommend that this column be replaced or shored before the end of December 2010. The four columns on the north side are in much better condition and exhibit minor rot, while one has cracks at the top.

Column #2: Serious Rot on Both Sides of Column; Also Missing Brackets

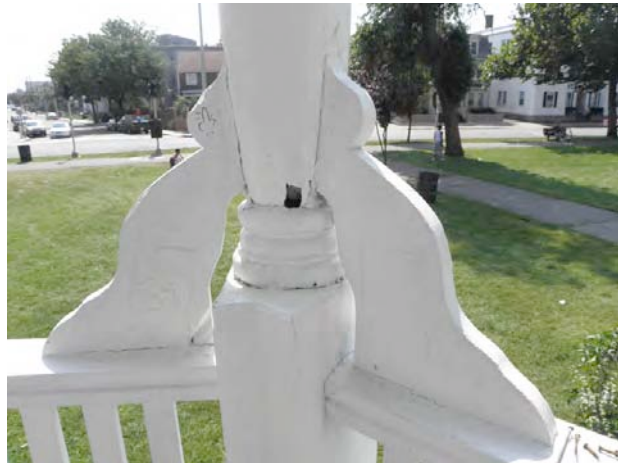
Column #3: Serious Rot at Base of Column

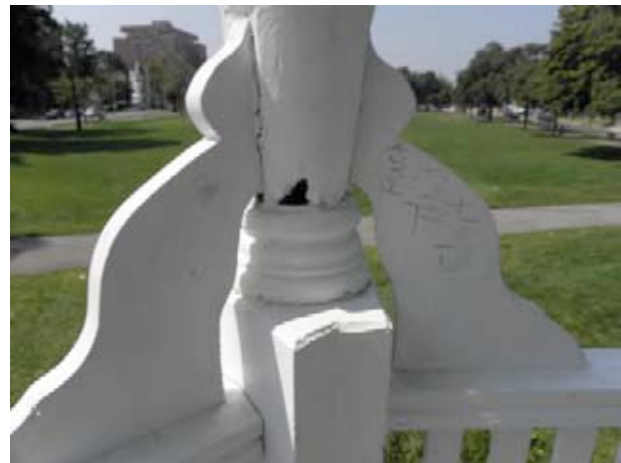
Column #4: Serious Rot at Base of Column

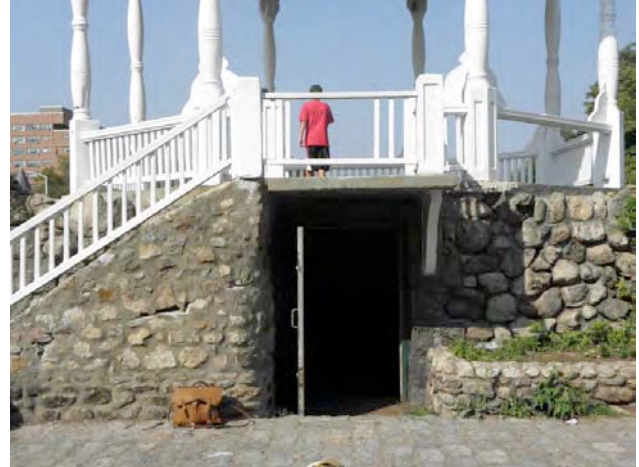
View of Existing Balustrade with Square
Balusters, Missing Balusters & Brackets

Originally, the balustrade was comprised of decorative round turned balusters, which were replaced in 1987 with straight wood slates that fit into a grooved two-by-four that collects water and accelerates rot. As shown in the above photo, some balusters and brackets are now missing.

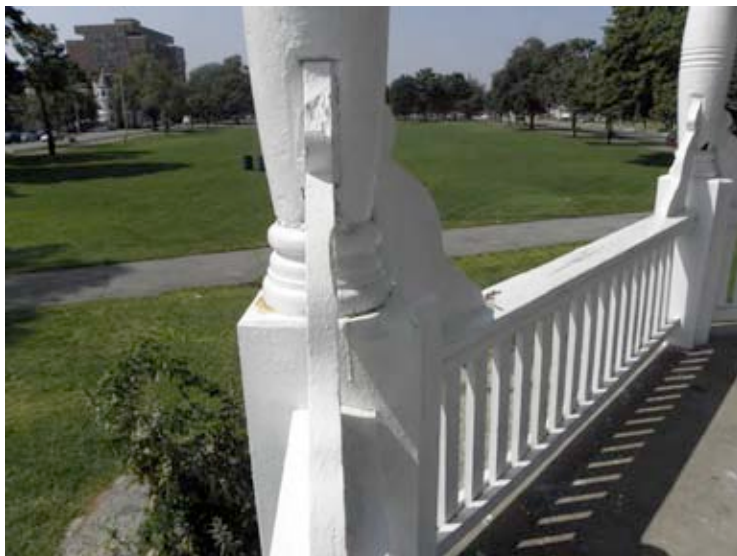
The original brackets that connect the columns and the balustrades were also replaced in 1987. Column #2 is missing both brackets. In addition, all of the new brackets were cut from stock lumber and their width is smaller than the original brackets, as evidenced in the two photos below, which show a wider shadow at the connection on the column. The form of the brackets seems to reflect those of historic photographs.

Column #3 Showing Shadow of Larger Original Bracket

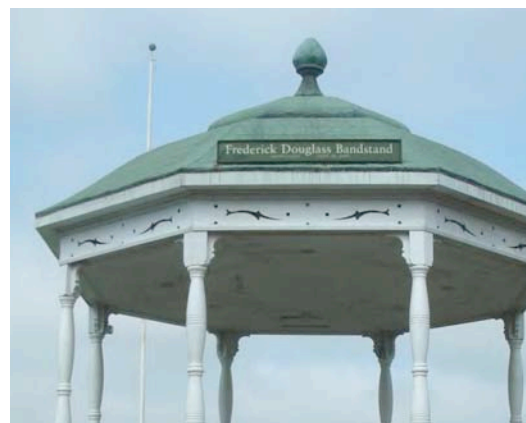
Existing View of Roof Edge without
Drip Edge Molding and Profile

The lack of a molding and a distinct profile to form the appearance of the original drip edge is a small but significant detail that has affected the character-defining features of the historic bandstand. The exposed plain wooden drip edge now appears wider and is stained by the roof water that drips down the face of the wooden drip edge. A small molding should be added back at the bottom edge of the roof to restore the profile and appearance of the original roof edge. The copper roof should extend over the top of the molding to create a distinct drip edge that empties rainwater directly to the ground rather than cascading down and staining the fascia board

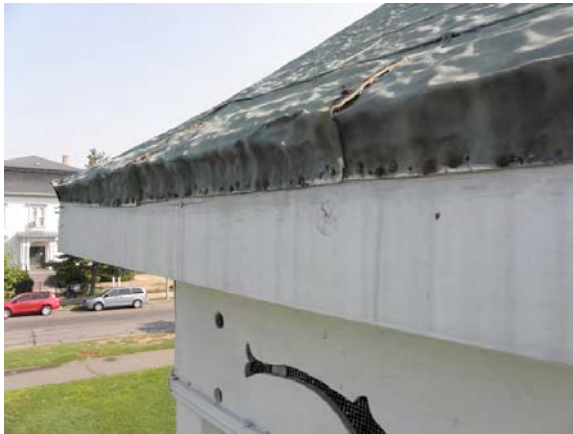
Existing View of Roof Edge without Drip Edge Moldings and Profile

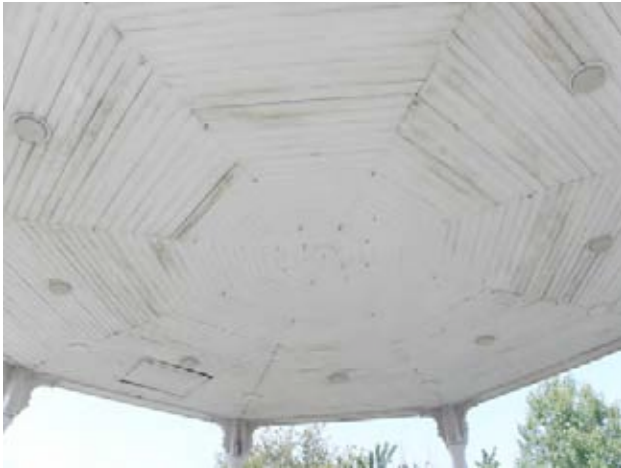
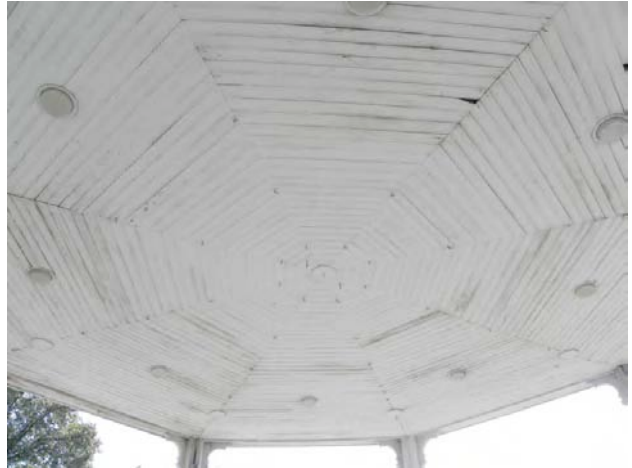
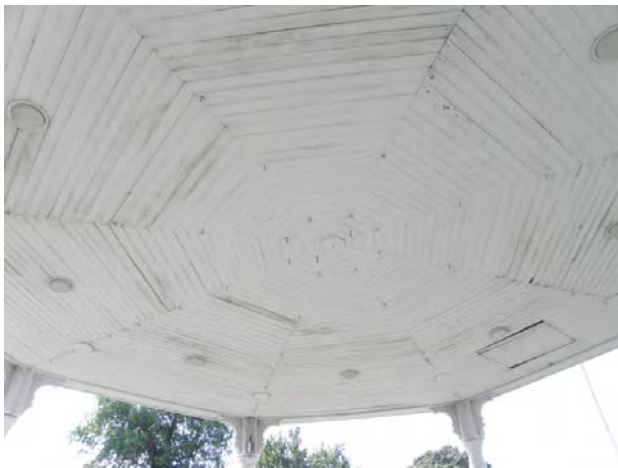
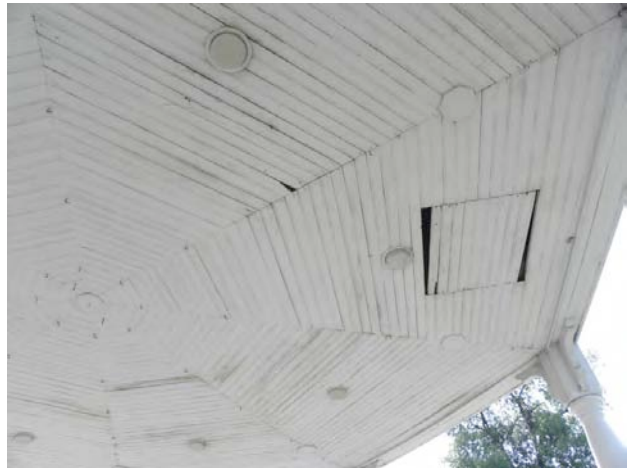
The tongue & groove wooden ceiling is in fair to poor condition, probably due to long-ago roof leakage and lack of periodic maintenance and painting.

The ceiling material and its arrangement is a significant feature of the bandstand, especially during any performance or presentation since the audience in proximity to the bandstand will be looking up at an angle where the ceiling will be highly visible. The pattern of the wooden ceiling should be retained with as much as possible of the tongue & groove boarding. The center of the ceiling is in the best condition and could be retained in place. Pieces that are damaged at their ends could be shortened to eliminate the damaged areas and reused as shorter pieces consistent with the ceiling pattern. New stock to exactly match the existing could be milled to fill in the remaining spaces. A new hatch cover should be constructed to exactly match the original and be hinged to open upward without damaging the edges.
