LYNN COMMONS

LYNN, MA

MASTER PLAN

FREDERICK DOUGLASS BANDSTAND,
LYNN COMMON HISTORIC DISTRICT, LYNN,
MASSACHUSETTS 01901

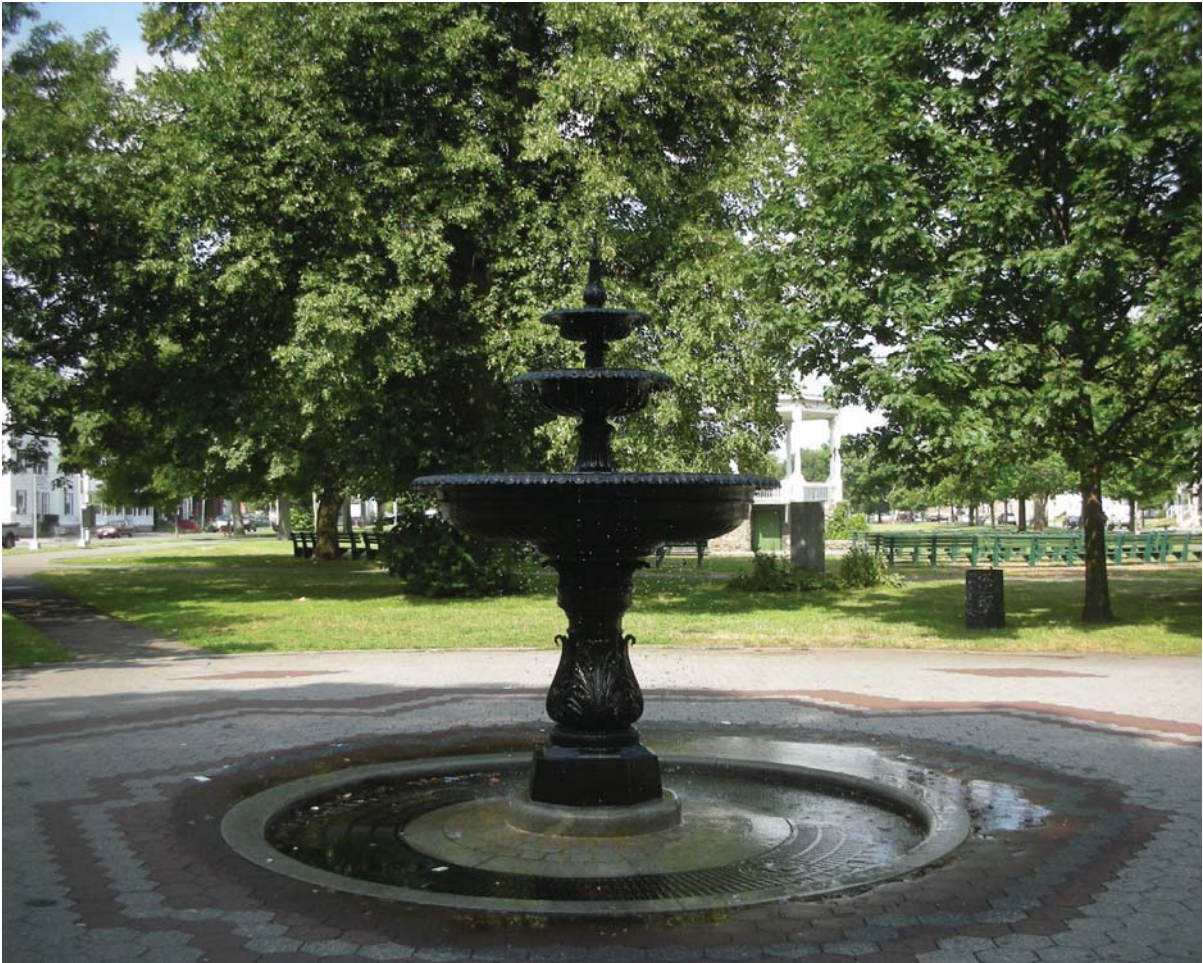
Current Fountain - July 2010

The current black fountain was added to the park in 1987. Before this fountain was installed, there was a frog pond with a central fountain. General Electric electrified the original fountain at the turn of the century. The 1987 fountain has three levels and did have a colored light display. The controls for the lights and the fountain were located underground and flooded in a rain storm. After the storm, the controls were moved to the comfort station. The company who designed the lights is no longer in business. The lights still work, but the computer controls and pumps do not. The refurbishment of the fountain, the lights and special effects is a second priority for the City of Lynn.

- Repair of the fountain and associated lighting effects,

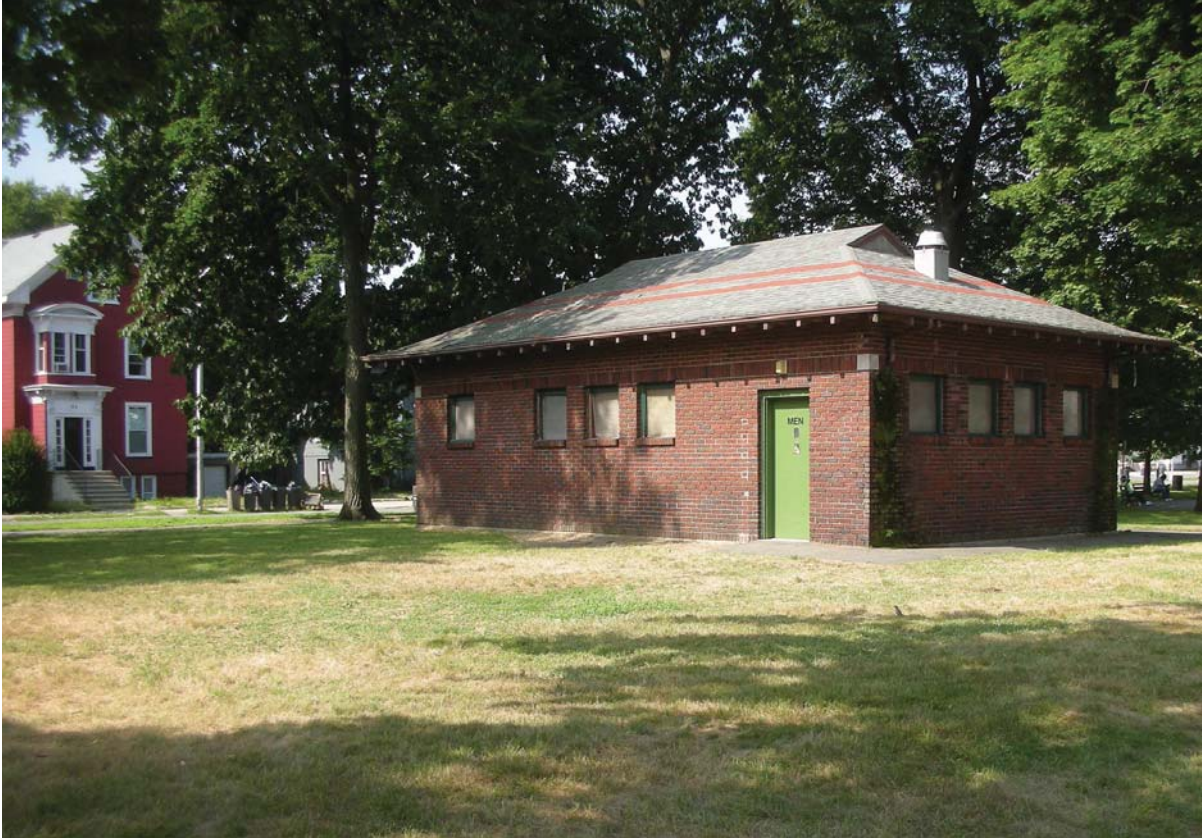
Comfort Station - July 2010

The comfort station is opened during functions. The windows have been boarded up. The electronics for the fountain are inside the comfort station. The interior of the comfort station needs to be upgraded.

The City needs to hire an architecture firm to assess the condition of the roof, walls and windows, to identify methods of complying with the Americans with Disabilities Act, to evaluate the condition of the interior, plumbing, fixtures and furnishings and to prepare plans and a cost estimate for the rehabilitation of the comfort station.

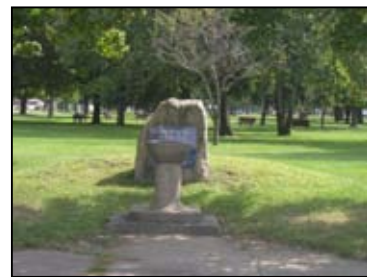
- HISTORY MEMORIAL LACKS SETTING

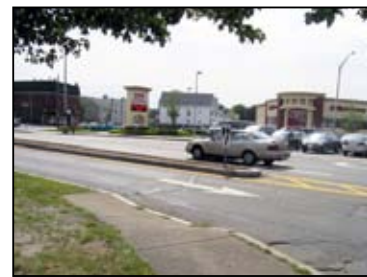
- NO CROSSWALK AT TRANSITION CURB RAMP

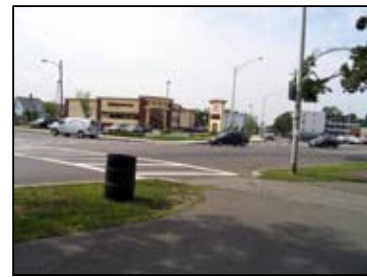
- ENTRANCE ON SOUTH COMMON STREET LACKS HISTORIC CHARACTER
- TRASH BARREL

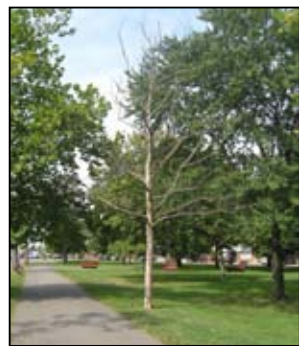
- DEAD TREE
- OTHER TREES WOULD BENEFIT FROM PRUNING

- Removal of dead and unhealthy trees,
- Tree pruning of mature trees to allow views into and out of the park,
- Planting of new trees resistant to the Asian Long Horned Beetle such as American Beech, American Linden, Pin Oak, Red Oak, and Tulip Trees.
- Attachment of labels to trees with species name.

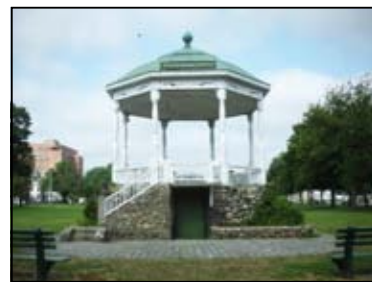
- HISTORIC BANDSTAND NEEDS RESTORATION

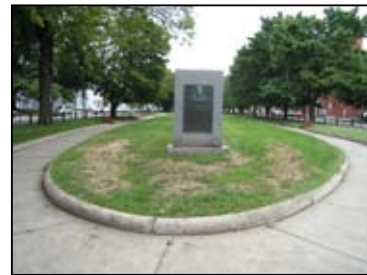
- JOHN MORRISSEY MEMORIAL
- LAWN NEEDS TO BE REFURBISHED

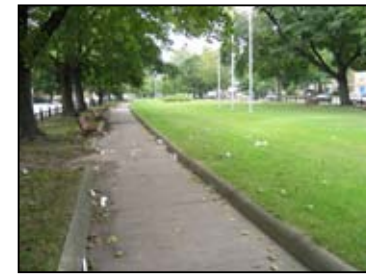
- TRASH ON PATH AND LAWN
- ADDITIONAL TRASH RECEPTACLES NEEDED

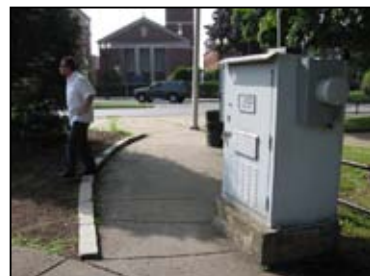
- UTILITY BOX LOCATED AT PARK ENTRANCE

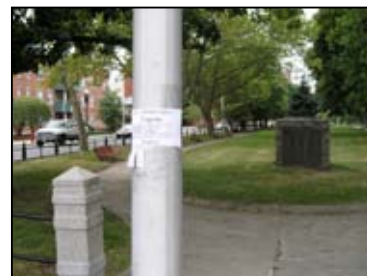
- POSTER ON LIGHT POLE

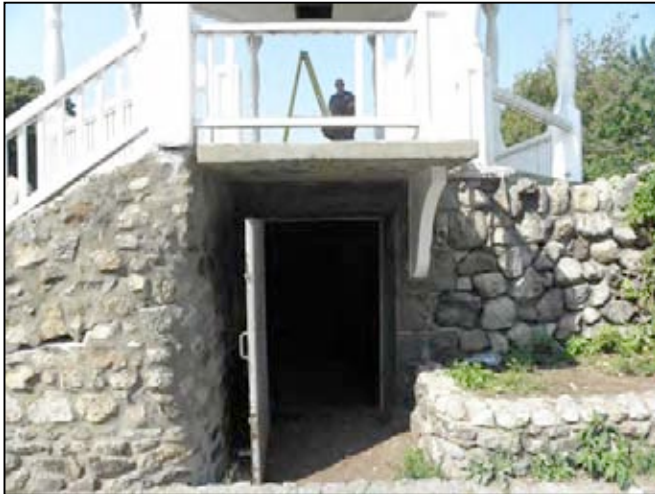
In 1987 a skim coat of masonry was applied to the entire floor and edges of the concrete. There is deterioration and loss of concrete at some of the northeastern corner edges where the floor supports the concrete column pedestals, also installed in 1987.

View of Floor Slab Over Basement Doorway

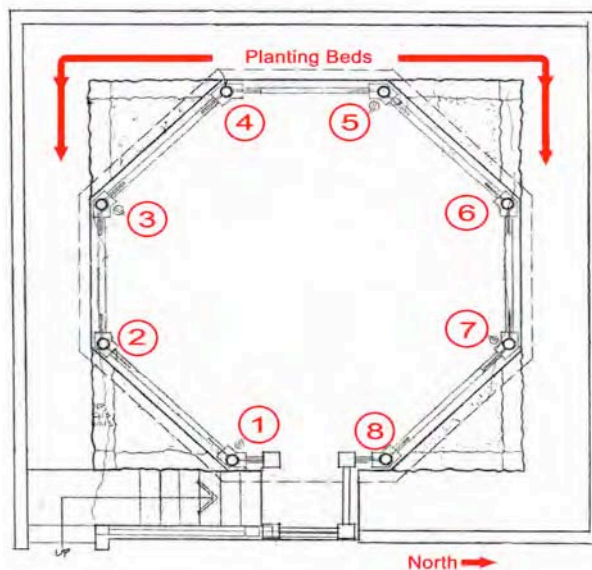
Location of Columns

Wooden Columns & Concrete Pedestals: The deteriorated wooden columns represent the most serious threat to the integrity of the bandstand. There are eight original wooden columns spaced 8 feet apart in a perfect octagon. The four columns on the south side have serious rot and loss of structural integrity (three at the bottom and one at the top). A screwdriver easily penetrated 5" into column 1. We strongly recommend that this column be replaced or shored before the end of December 2010. The four columns on the north side are in much better condition and exhibit minor rot, while one has cracks at the top.

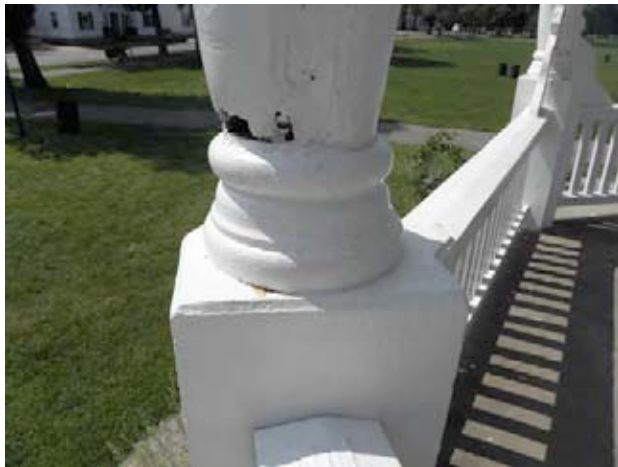
Column #2: Serious Rot on Both Sides of Column; Also Missing Brackets

The original brackets that connect the columns and the balustrades were also replaced in 1987. Column #2 is missing both brackets. In addition, all of the new brackets were cut from stock lumber and their width is smaller than the original brackets, as evidenced in the two photos below, which show a wider shadow at the connection on the column. The form of the brackets seems to reflect those of historic photographs.

| | - Replace Base of 3 Columns; Replace 6 Brackets: | \$ 7,000 - 9,000 |

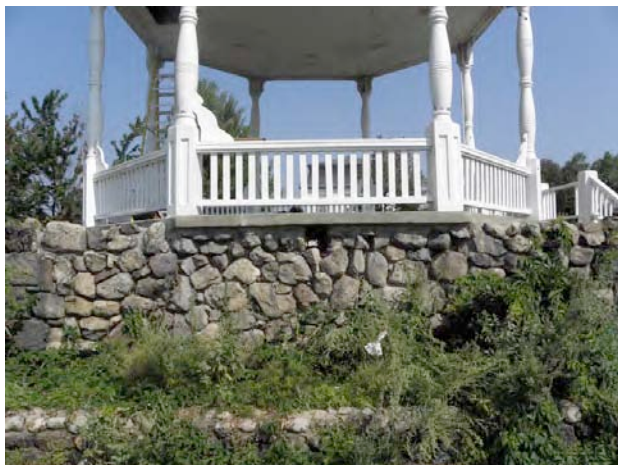
The concrete pedestals that support the wooden columns were installed as part of the 1987 repair work. The pedestals were originally wood but during the 1987 repair work, it was determined that they were beyond repair. They were replaced with concrete pedestals including those of the stairway. These pedestals are in good condition.

Concrete Pedestals for Wooden Columns on South Side of Bandstand

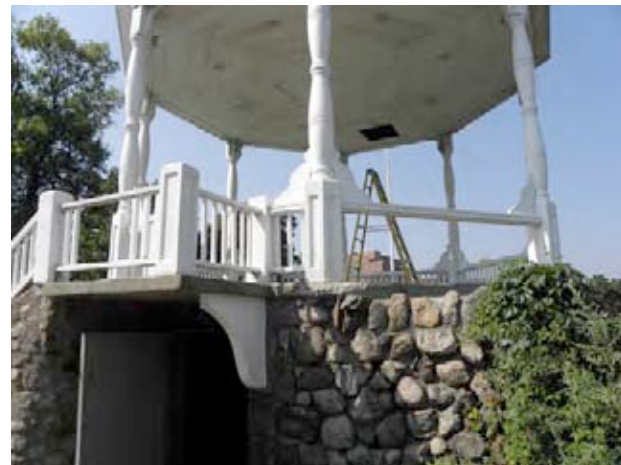
Concrete Pedestals for Stairway Balustrade

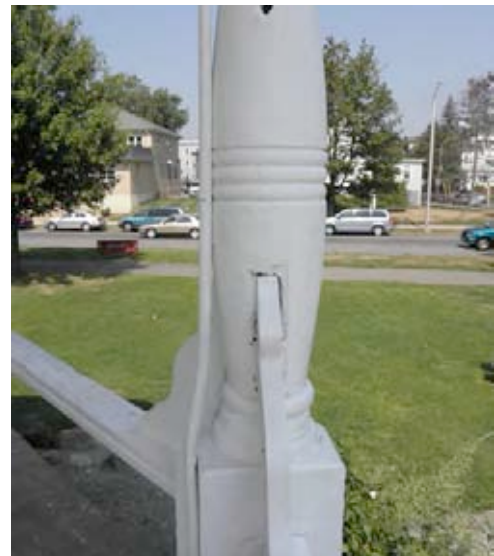
Column #8 Showing Shadow of
Larger Original Bracket

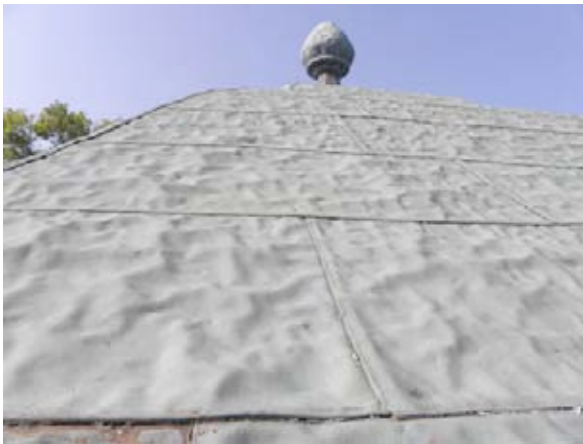
- *Patinated Copper Roof:* The octagonal roof is covered with stamped copper consisting of sheets joined with seams and topped with an acorn-shaped finial sometimes known as a pommel. The metal sheets appear to have been stamped to achieve a gently textured appearance that has patinated over time to a greenish-gray dull appearance. The sheets are in relatively good condition except where damage has occurred from heavy objects that have been thrown onto the roof. In addition, some seams are deteriorated but there appears to be little evidence of recent roof leakage.

Textured Appearance of Copper Alloy Sheets
Joined with Seams

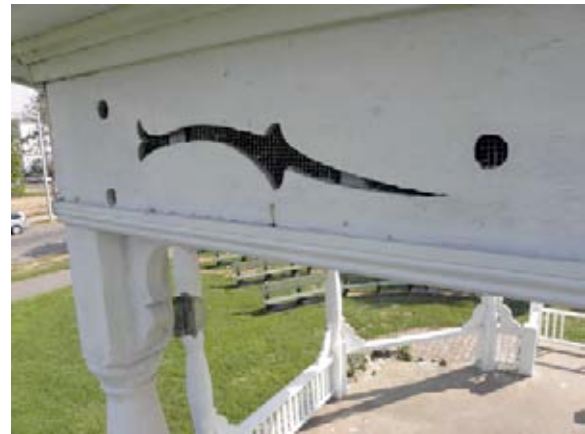
Existing View of Fascia Board with Decorative Period Cutouts

- *Wooden Fascia:* The wooden fascia boards between the roof and the top of the wooden columns were all replaced in the 1987 repairs. The 1987 replacements are faithful reproductions of the original fascia with accurate ventilation cutouts, which are all screened on the inside to prohibit the entrance of insects or birds into the enclosed roof structure. The fascia is in good condition. A small molding was including at the bottom of the fascia but does not detract from the original appearance.
- *Roof Structural System:* The attic or loft space above the bandstand is accessed through a hatch in the bandstand's tongue and groove wooden ceiling. This low space contains the structural system that supports the roof and the wooden ceiling as well as the recessed lighting system.

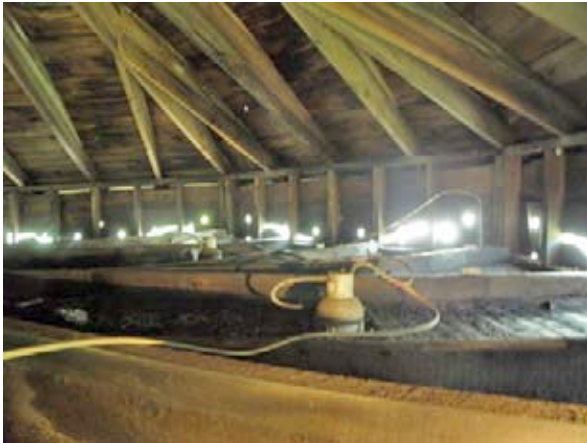
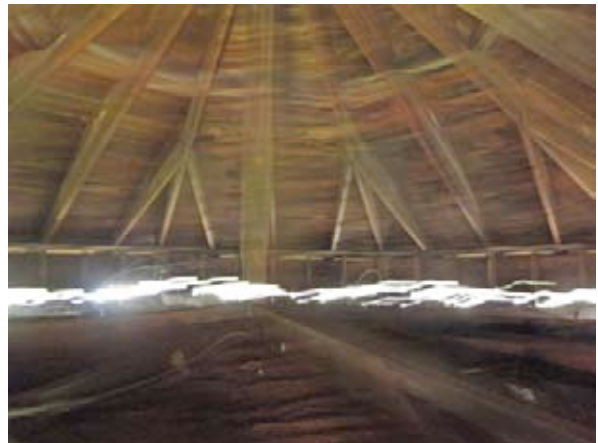
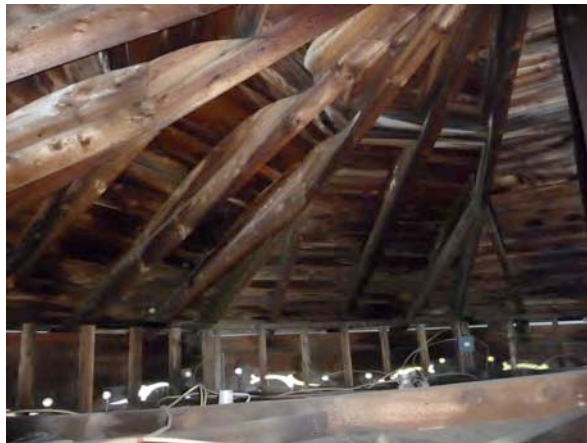
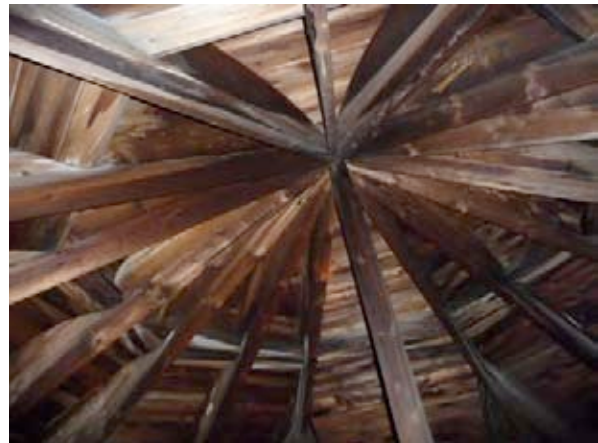
The 1987 repairs included an inspection of the roof structural system and replacement or reinforcement of any structurally unsound, rotten or water damaged wooden members. A visual inspection from the ceiling hatch was made as part of this study. The roof structural system appears to be in good condition without any significant deflection. New recessed lighting was installed in the ceiling of the bandstand to light the bandstand floor below.

From the Ceiling Hatch Looking at the Southern Roof and Fascia

From the Ceiling Hatch Looking at the Center Post that Holds Up the Ceiling

From the Ceiling Hatch Looking at the Northern Roof and Fascia

From the Ceiling Hatch Looking Up at the Center of the Roof

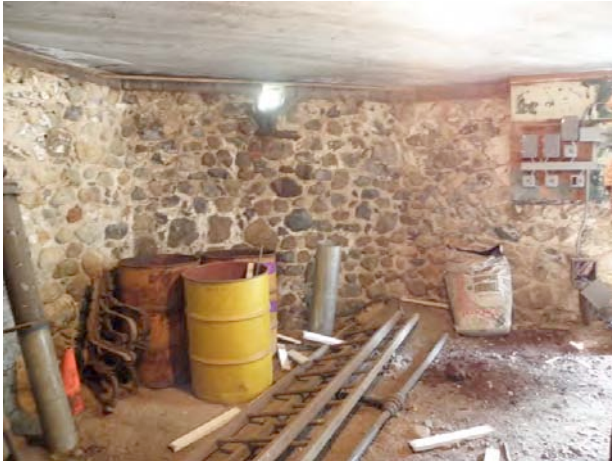
Electrical System: Electricity is provided to the bandstand by an underground line from the east that passes down the center aisle between the curved rows of park benches and comes into the basement just to the right of the basement doorway to an electrical panel mounted on the basement wall above.

Basement View Showing Electric Underground Service Leading to the Electrical Backboard.

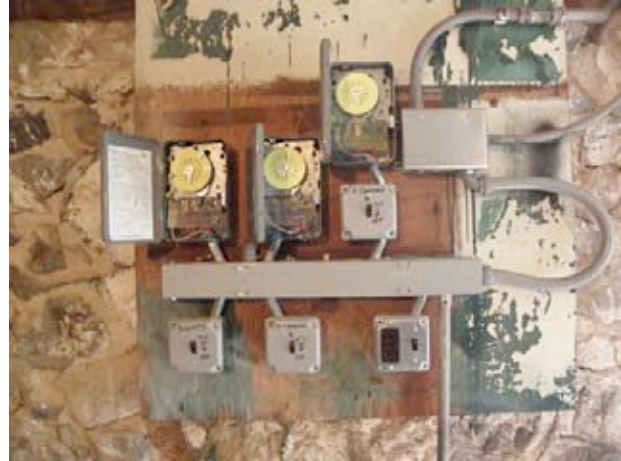
Detail of Electric Time Clocks & Switches Just Inside of Basement Doorway. (The Electric Panel is Located in the Adjoining Bath House.)
